HUDSON VALLEY ENERGY CONSULTANTS

REPORT SUMMARY

Thermal Report

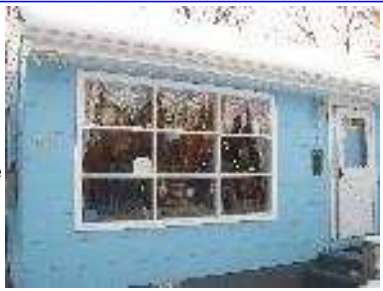
Type, Double hung single pane with triple track storm windows and single pane uninsulated. Condition, Appear to be in generally acceptable condition. Unless triple track storm windows have been installed and are in good condition, it can be cost effective to rplace the single pane windows with double pane or install a storm window. The front living room window would be cost effective to replace.

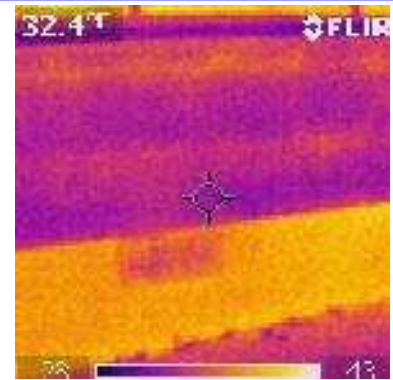
Exterior

These images clearly show the heat loss around the perimeter of the house where the floor rests on the foundation. Even if the walls are insulated, improper or lack of air sealing around the rim joist will allow for a substantial amount of heat loss and outside air infiltration. Roof connections can be areas of concern as they are "outside" of the house but have attic spaces that may be connected to the conditioned house.
