TOP AND BOTTOM - A ONE/TWO PUNCH FOR SAVINGS

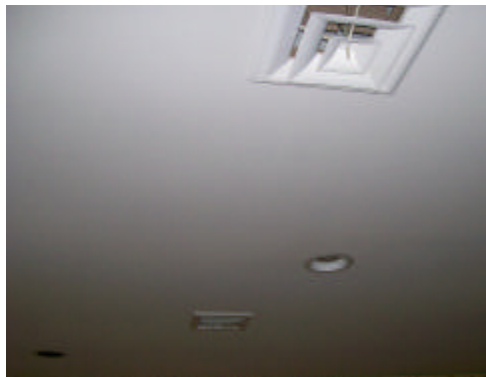
Typical “holey” ceiling

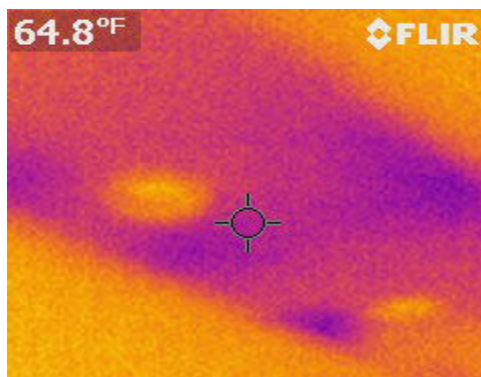
Heat loss in winter will also be heat gain in the summer

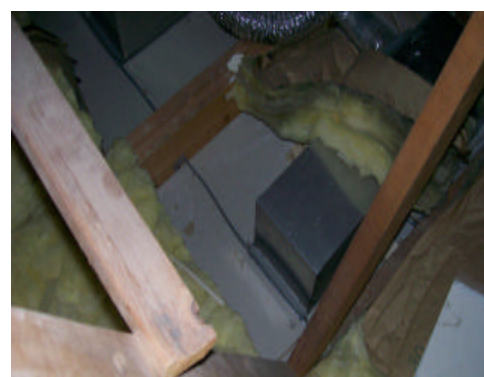
The culprit! It all adds up.

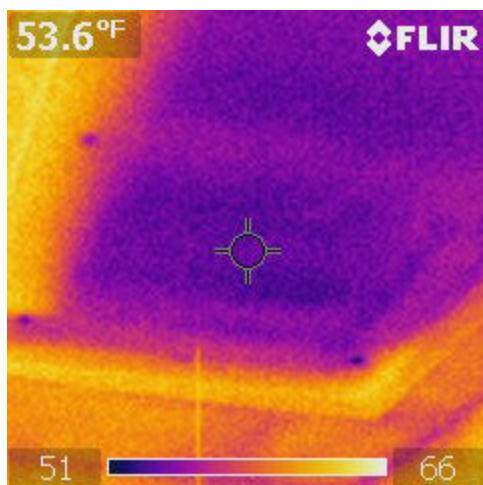
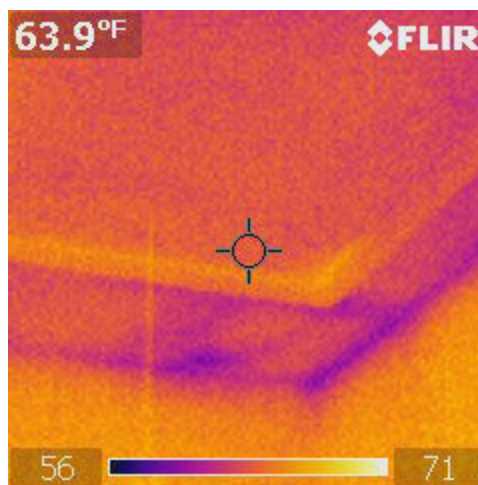
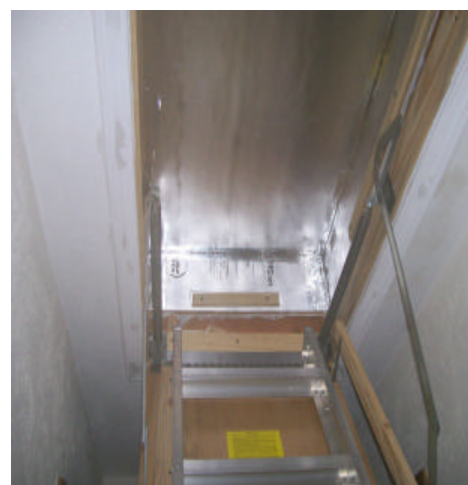
A simple insulated hatch cover has made a 10 degree difference in this section of ceiling. Add in caulking and covering recessed lights and the next time you go into the attic remember to wear your coat! The great thing about these covers is that they also work wonders in the summer as they keep the hot attic air from radiating into the house (remember - heat moves towards cold in any direction!)

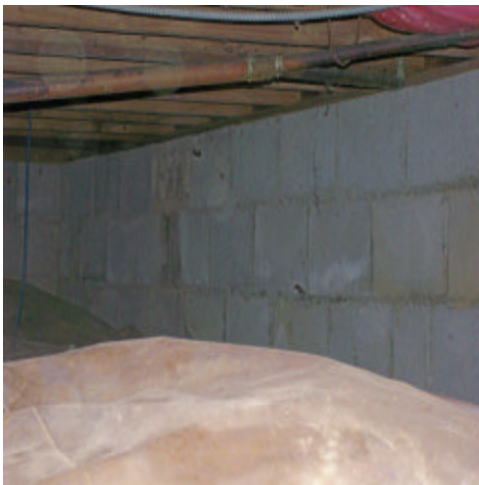
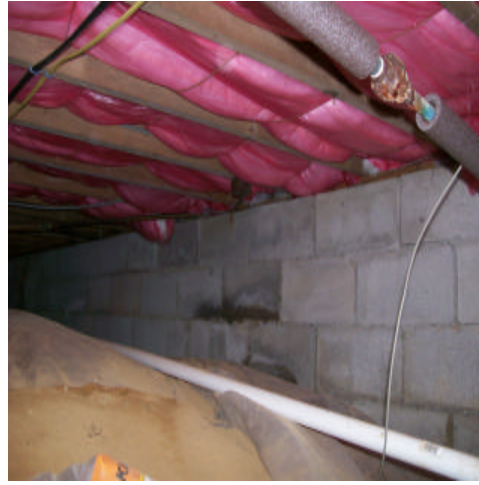
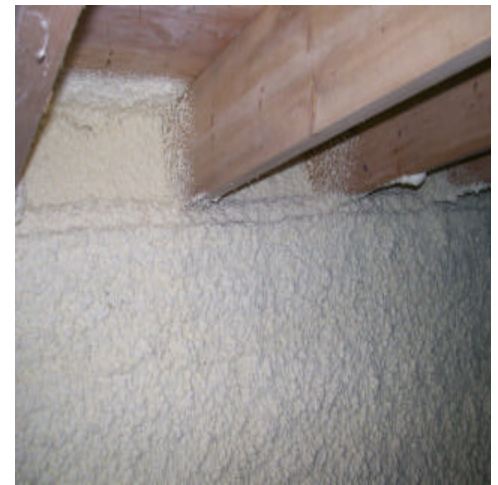
The thermal image shows the line where the work was stopped as a major difference in heat loss. The left side of the foundation has not yet been completed and the right side only has one inch of insulation so far (it will get 3 inches). It really works!

Now to the bottom. Even if done poorly, the builder always seems to make an attempt to insulate the attic. But the bottom of the house, either a full basement or crawlspace doesn't always get the same courtesy. Especially in a crawlspace, if it is vented (openings in the foundation wall that allow outside air to circulate) then the ceiling needs to be insulated. But that's only half the job. What we've learned through diagnostic testing (building science) is that sealing the rim joist and sill plate are just as, if not more important, because it helps stop the airflow. (The rim joist and sill are the part of the flooring system that rests on the foundation, surrounds the house, and is in contact with the outside air). Any heat reaching the rim joist is lost to the outside. The photos below show an exposed sill plate and rim joist, a poorly insulated ceiling (the thermal images show about the same heat loss in both, and a foamed rim and wall system that can made a big difference in both heat loss and drafts..
