HUDSON VALLEY ENERGY CONSULTANTS

THERMAL IMAGING REPORT

Prepared for: Anyone

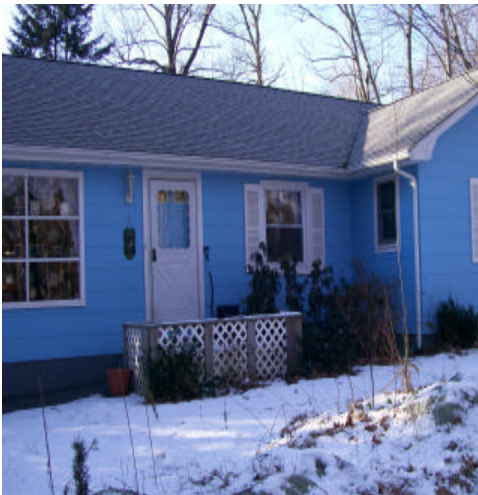
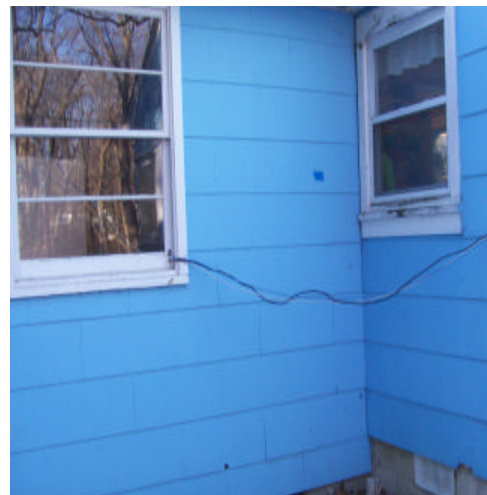
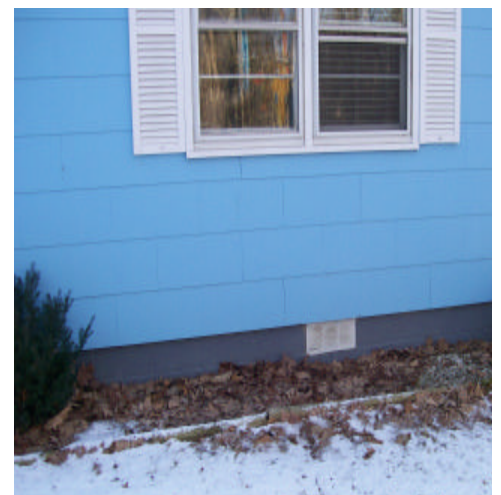
Inside corners typically have loose insulation as it has to be cut to fit into thinner cavities than the rest of the wall.

Even if insulation is present, if it is not in contact with the finished wall surface, it will not be effective. The center photo is an insulated wall before the interior wallboard was completed.

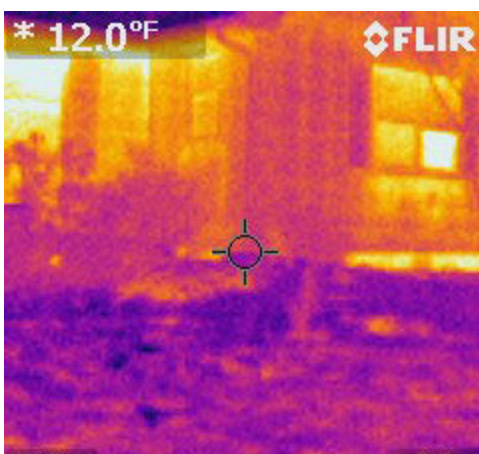
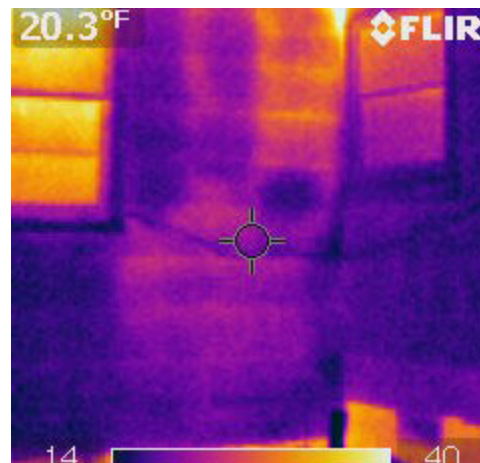
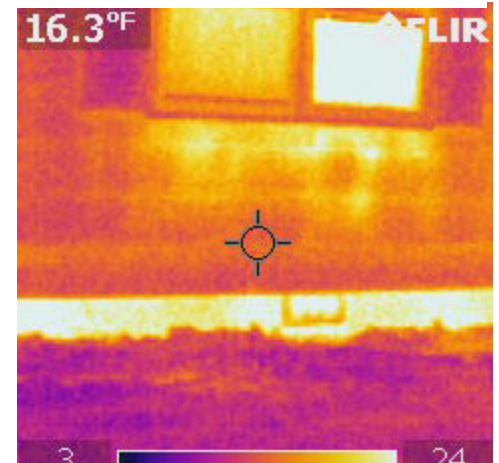
As the lighter areas are signs of heat loss, the foundation and rim joist (where the floor sits on the foundation or the first and second floor meet) show typical heat loss. If the structure is accessible from the basement or crawlspace, foam insulation would be an advisable and cost effective treatment.

Insulate accessible rim joists in basement and crawlspace.

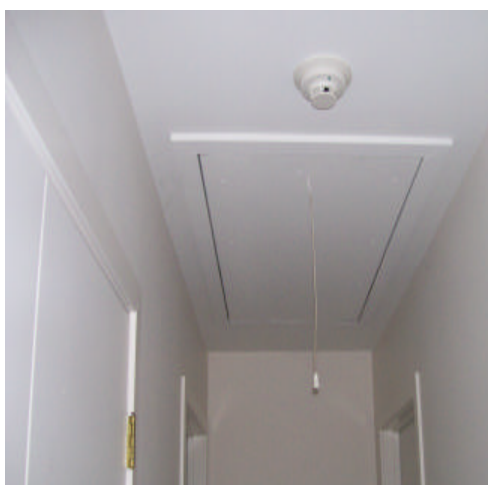
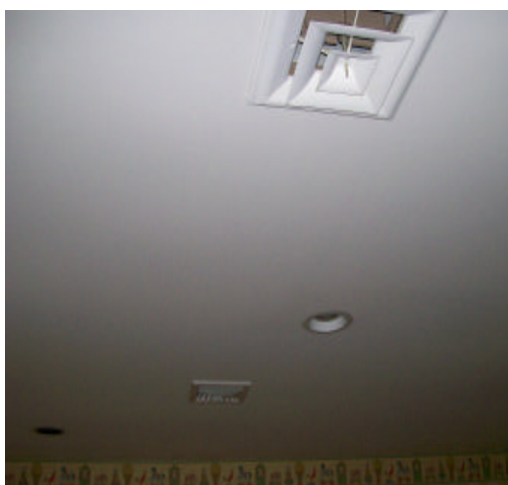
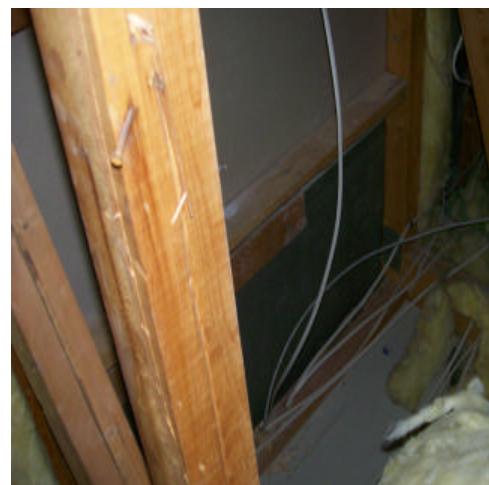
Probably the largest but easily repaired openings into the attic are hatches (pull down stairs are major heat loss and air leakage sources), whole house fan louvers, and recessed lights. If you do nothing else to control heat loss, sealing attic penetrations will make a difference.

Insulate and seal the attic access and whole house fan.

Have covers made for the recessed lights that provide at least 3” of clearance between the box and the fixture or replace the fixtures with ones that can be in contact with insulation (called ICATs - in contact and air tight).

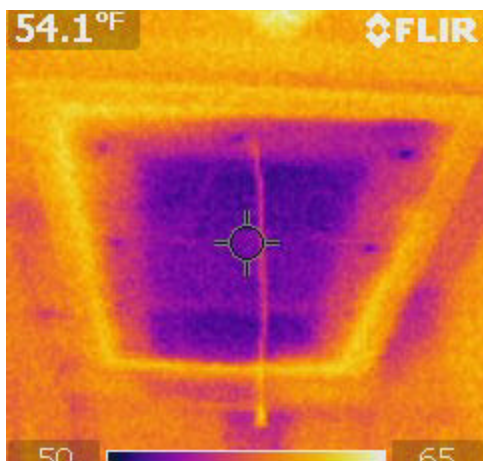
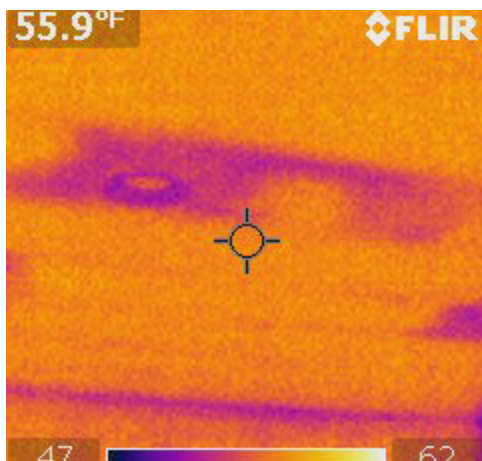
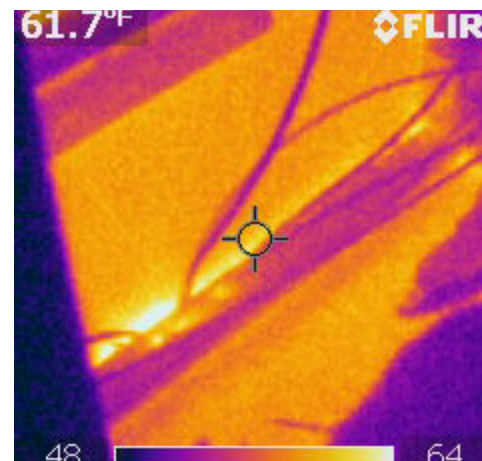
A major source of heat loss is often hidden under the insulation. The tops of interior partition walls are filled with holes for wires and pipes that connect the interior conditioned rooms to the attic. Even though the insulation looks good, it is not an air seal. These holes need to be filled. If you can feel cold air coming out of a first floor outlet, it’s probably being pulled into the house because warm air is leaving through the attic.

The third photo is from the attic. Because the attic is ventilated it is supposed to be close to the temperature outside. Look at the heat (62 degrees worth) coming through the wire holes and ceiling where the insulation is missing. These are not hard to fix when you know what you’re looking for!

Lift insulation above partition walls and seal wire penetrations and gaps in the wallboard.
